TimesOne™
The Energy Efficiency Company

**EXTERIOR OF THIS MINISTRY HOUSE WAS PAINTED WITH MULTICERAMICS
TINTED WITH CERAMICS**

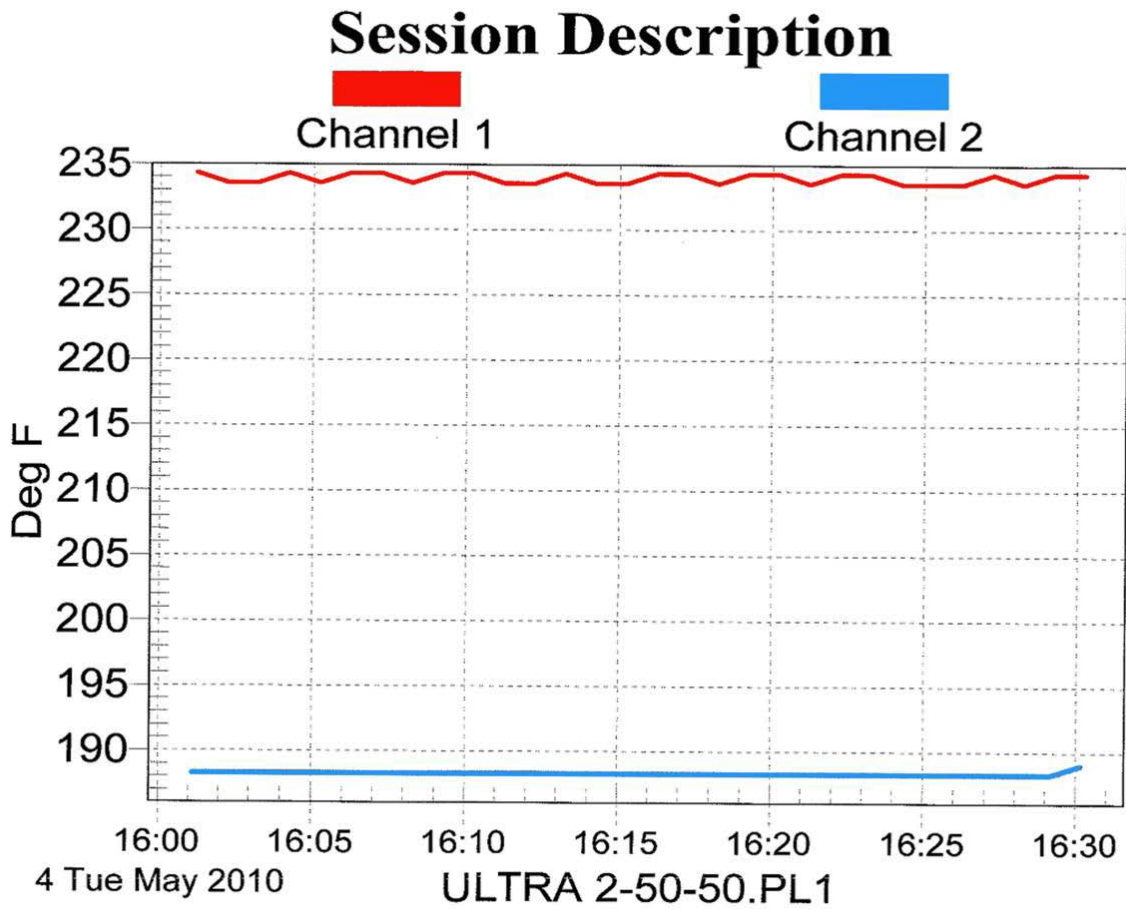
THIS CHART SHOWS THE DIFFERENTIAL ON CONDUCTIVITY ALONE, A 7 mils COAT ON A METAL PLATE THE PLATE WAS PLACED OVER A DIGITAL HOT PLATE SET AT 235F CONSTANT TEMPERATURE (RED LINE).

A PAIR OF DATA LOGGER THERMO COUPLERS WERE USED TO MONITOR TEMPERATURE ON BOTH SIDES OF THE PLATE, GRAPH SHOWS 30 MINUTES TRACKING AFTER STABILIZATION, BUT THE TESTS SHOWED NO CHANGES DURING THE EIGHT HOUR RUN.

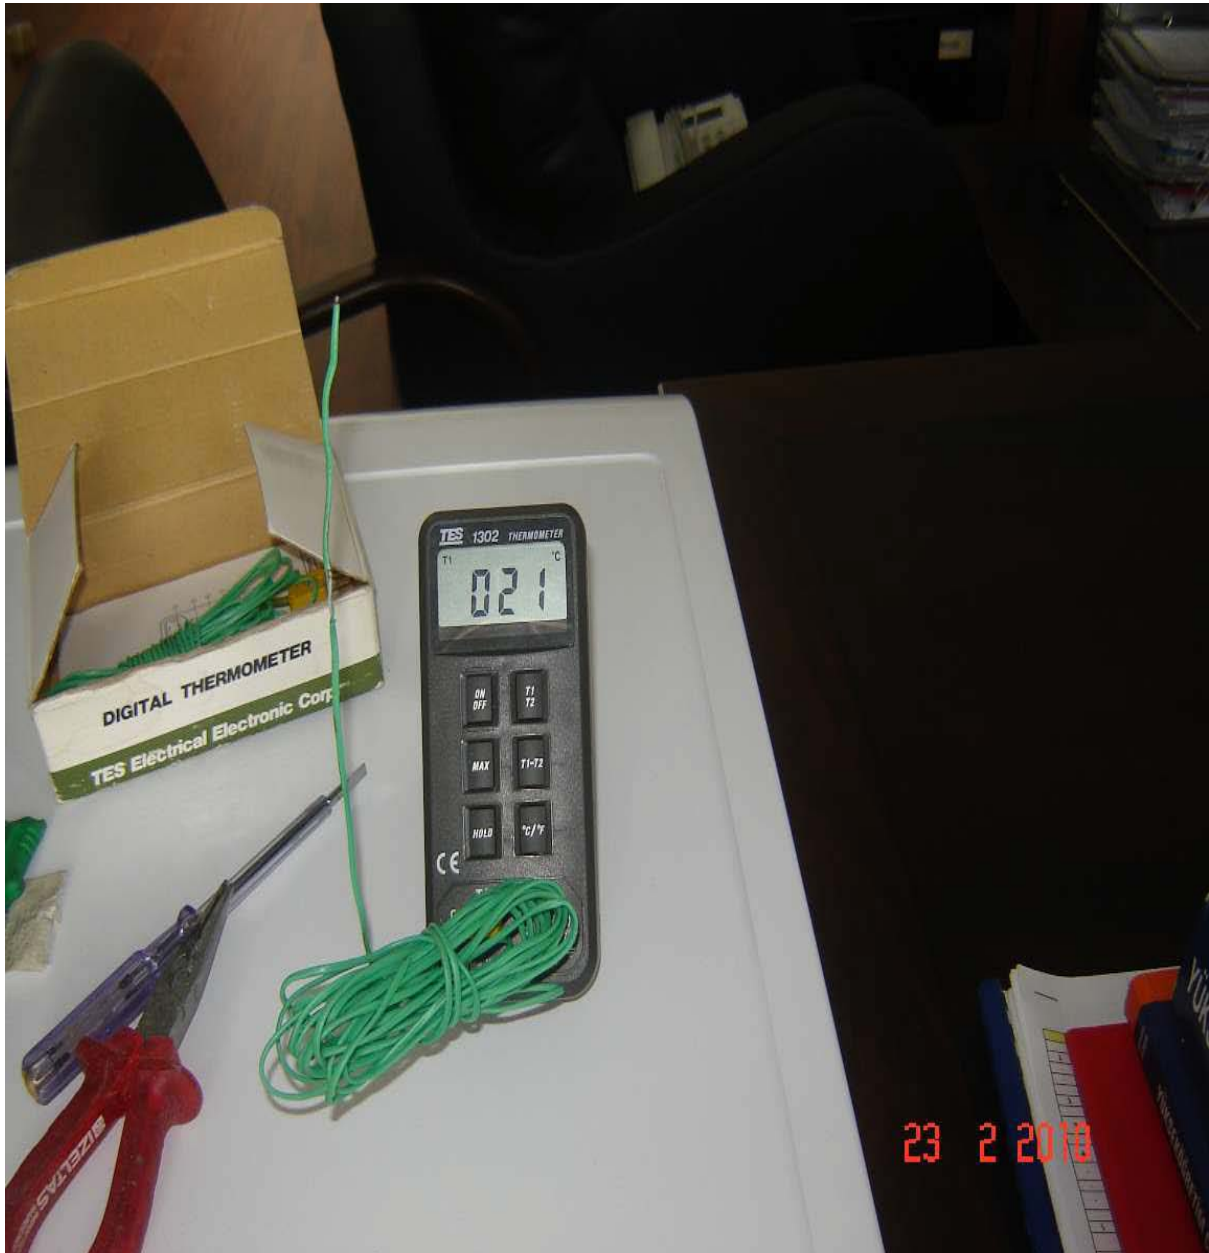
INTERIOR TEMPERATURE WITHOUT CONDITIONED ENVIRONMENT (INTERIOR WAS ALSO PAINTED WITH MULTICERAMICS) SHOWS 21C (69.8F)

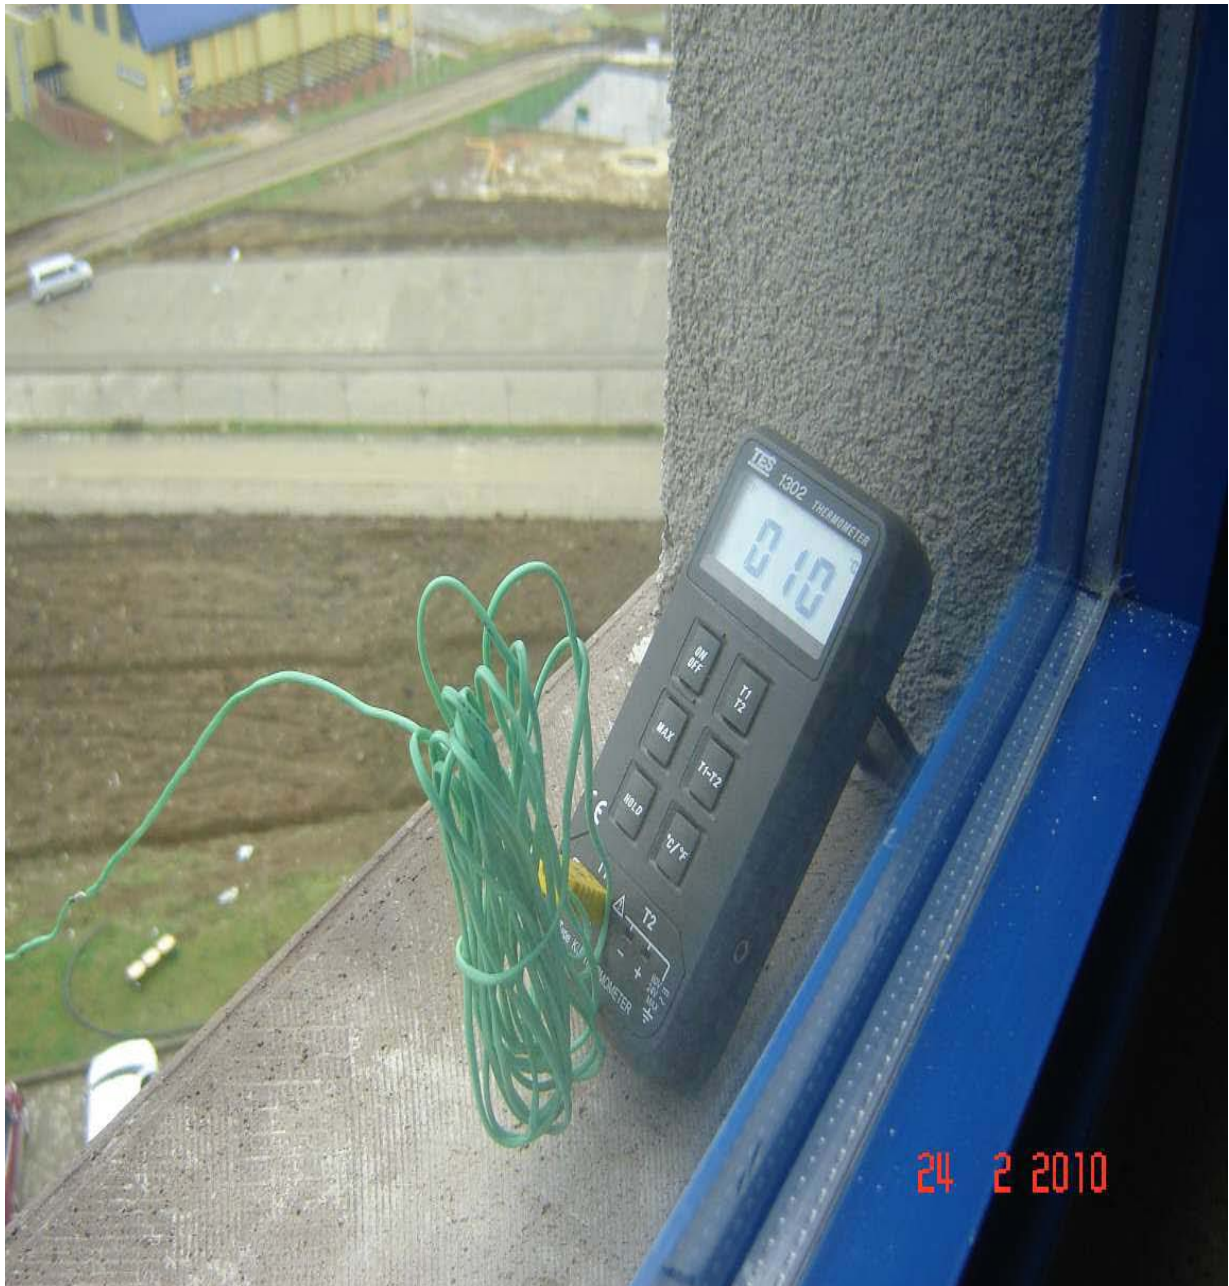
EXTERIOR TEMPERATURE WAS CONTINUOUSLY TRACKED AND THE DIFFERENTIAL TEMPERATURE AFTER THE ONE DAY CURING TIME WAS 11C
